Duxbury Beach Continues to be Managed with Innovative Environmental Approaches

*Prepared by Jim O'Connell,
Vice President, Duxbury Beach
Reservation, Inc., 11-16-06*

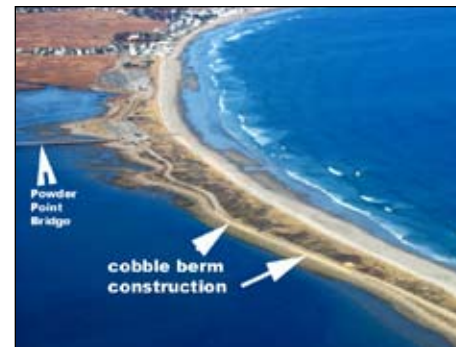
Photos: (1) aerial view of section of road eroding, (2) backhoe preparing to lay cobbles, (3) cobble berm in place

Alternatives for mitigating the erosion along the back road are limited by strict environmental regulations. The Reservation selected and received approval from the Duxbury Conservation Commission for an innovative nonstructural cobble berm solution. The cobble berm is a moderately sloping ramp of cobble-sized stone (small, naturally round stones) placed up against the side of the road that is eroding. The beach in the location of the new cobble berm already consists of a mix of pebble and cobble, so the cobble berm is compatible with the existing environment.

Cobble berms work to prevent or slow erosion by allowing storm-wave uprush to quickly percolate through the large spaces between the individual stones, thereby preventing the stronger wave
