## DUXBURY BEACH RESERVATION, INC.

# Duxbury Beach Park Dune & Beach Restoration

### Project Overview

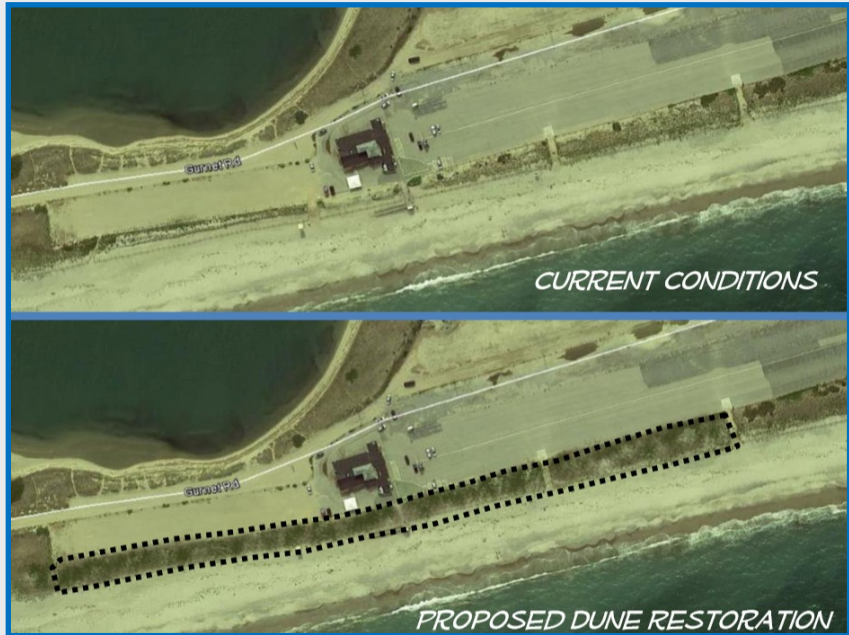
Before & After

- ⇒ 1,000 linear feet
- ⇒ Add 50,000-60,000 tons of compatible material
- ⇒ Elevate crest of dune to 16.5ft NAVD88
- ⇒ Widen dune width to 50ft
- ⇒ Elevate beach berm to 6.5ft NAVD88
- ⇒ Create slopes 1:10 or milder
- ⇒ Plant 22,000 culms American Beach Grass 36in on center

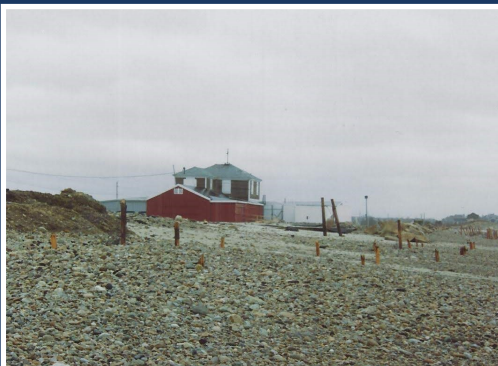
Dec 1992: DBP dunes overwashed

Historically, many of the attempts to protect the Pavilion and surrounding infrastructure through cement blocks and tie-rods have been unsuccessful. Dune and beach re-nourishment bolsters the natural state of the beach—even when sand is lost, it remains in the system and continues to strengthen the barrier beach.

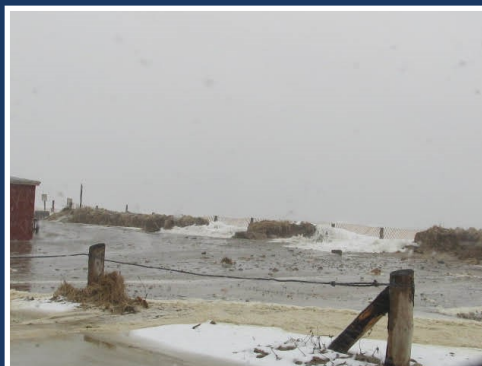
March 2013: Flooding in DBR lot

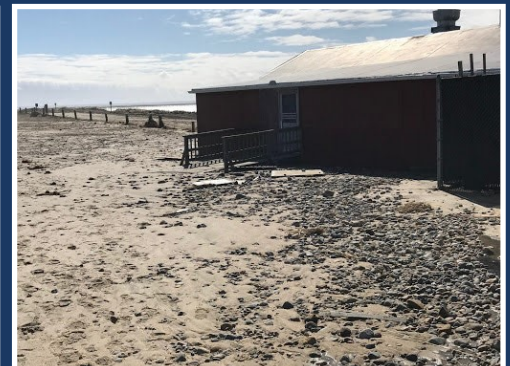
March 2018: Sand and cobble washed through pathways
